Neutral Citation Number: [2017] EWHC 558 (TCC)

IN THE HIGH COURT OF JUSTICE
QUEEN'S BENCH DIVISION
TECHNOLOGY AND CONSTRUCTION COURT

**Leeds Beckett University (formerly Leeds
Metropolitan University)
- and -
Travelers Insurance Company Limited**

Approved Judgment

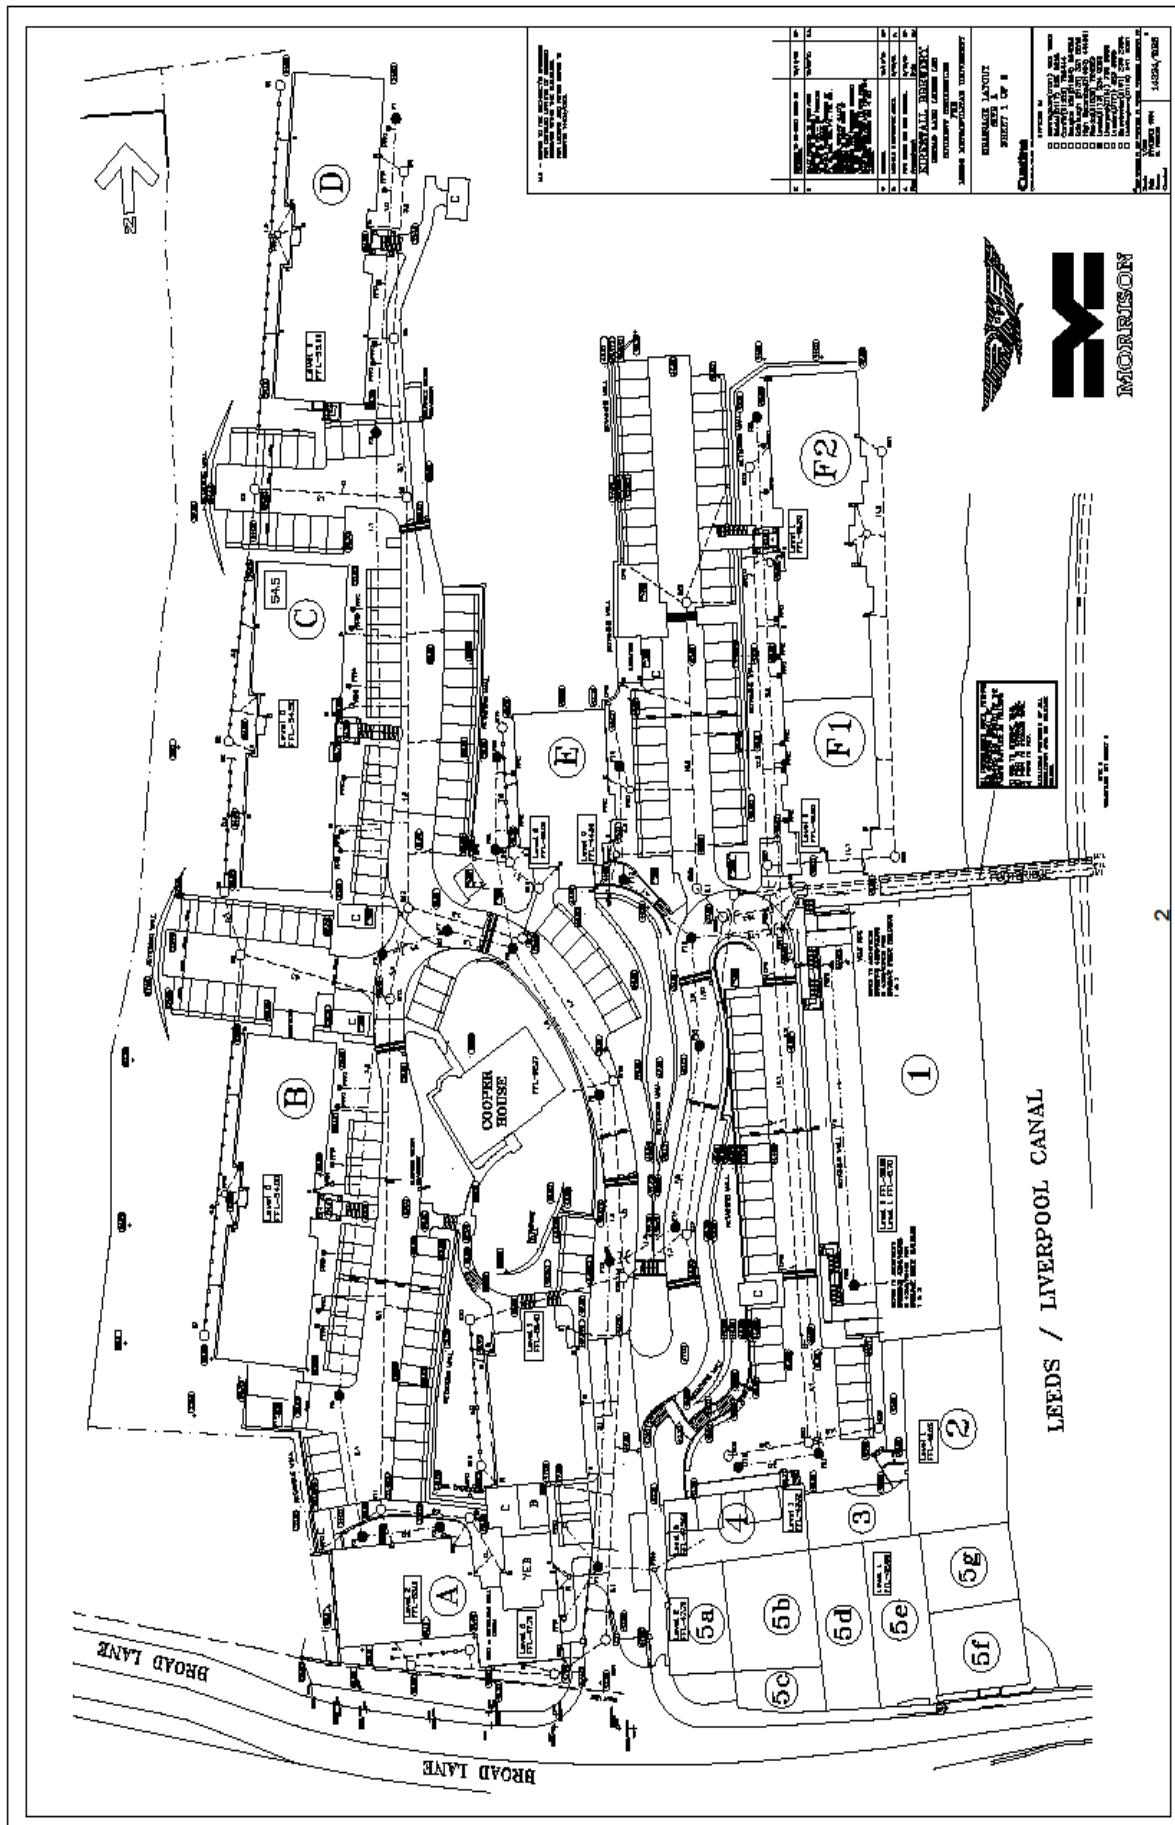
1. Between 1993 and 1996, the claimant (“the University”) carried out an ambitious building project on the site of the former Kirkstall Brewery, on both sides of the Leeds-Liverpool canal in north-west Leeds. The project involved not only the refurbishment of the existing brewery buildings, but the design and construction of several new accommodation blocks. Because these blocks were designed to match the existing buildings, they were, from an aesthetic point of view, considerably more attractive than the typical undergraduate block. The largest of these buildings, containing both the Bridge Building (F1) and the Turner Building (F2), was located adjacent to the western bank of the canal. I shall call it “the F1/F2 Building”. It is shown on *Figure 1*.

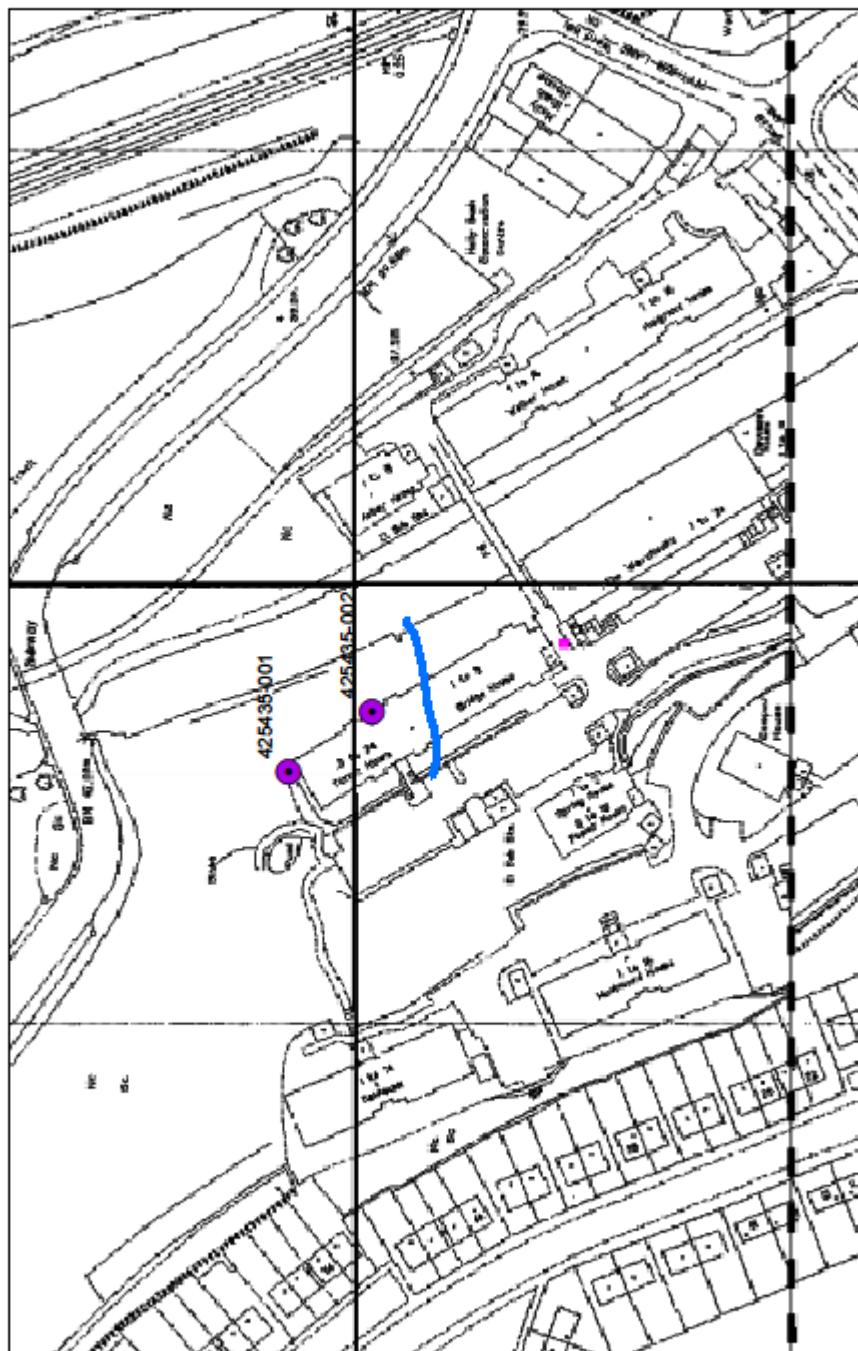
31. The map provided by British Coal with their letter was dated 19 November 1993. It showed the locations of the two mine shafts to which they had referred. They were on the north-eastern side of the site, just to north of the watercourse. The map described them as “the approximate location(s) of known disused coal mine outlets under or close to the property to which the attached report relates...”
32. Investigations have shown that the location of the southern mineshaft (as indicated by British Coal) was within the footprint of the F1/F2 Building, in the area of the greatest blockwork damage. The northern location was just beyond the north-eastern corner of the F1/F2 Building. They are marked on *Figure 2*.

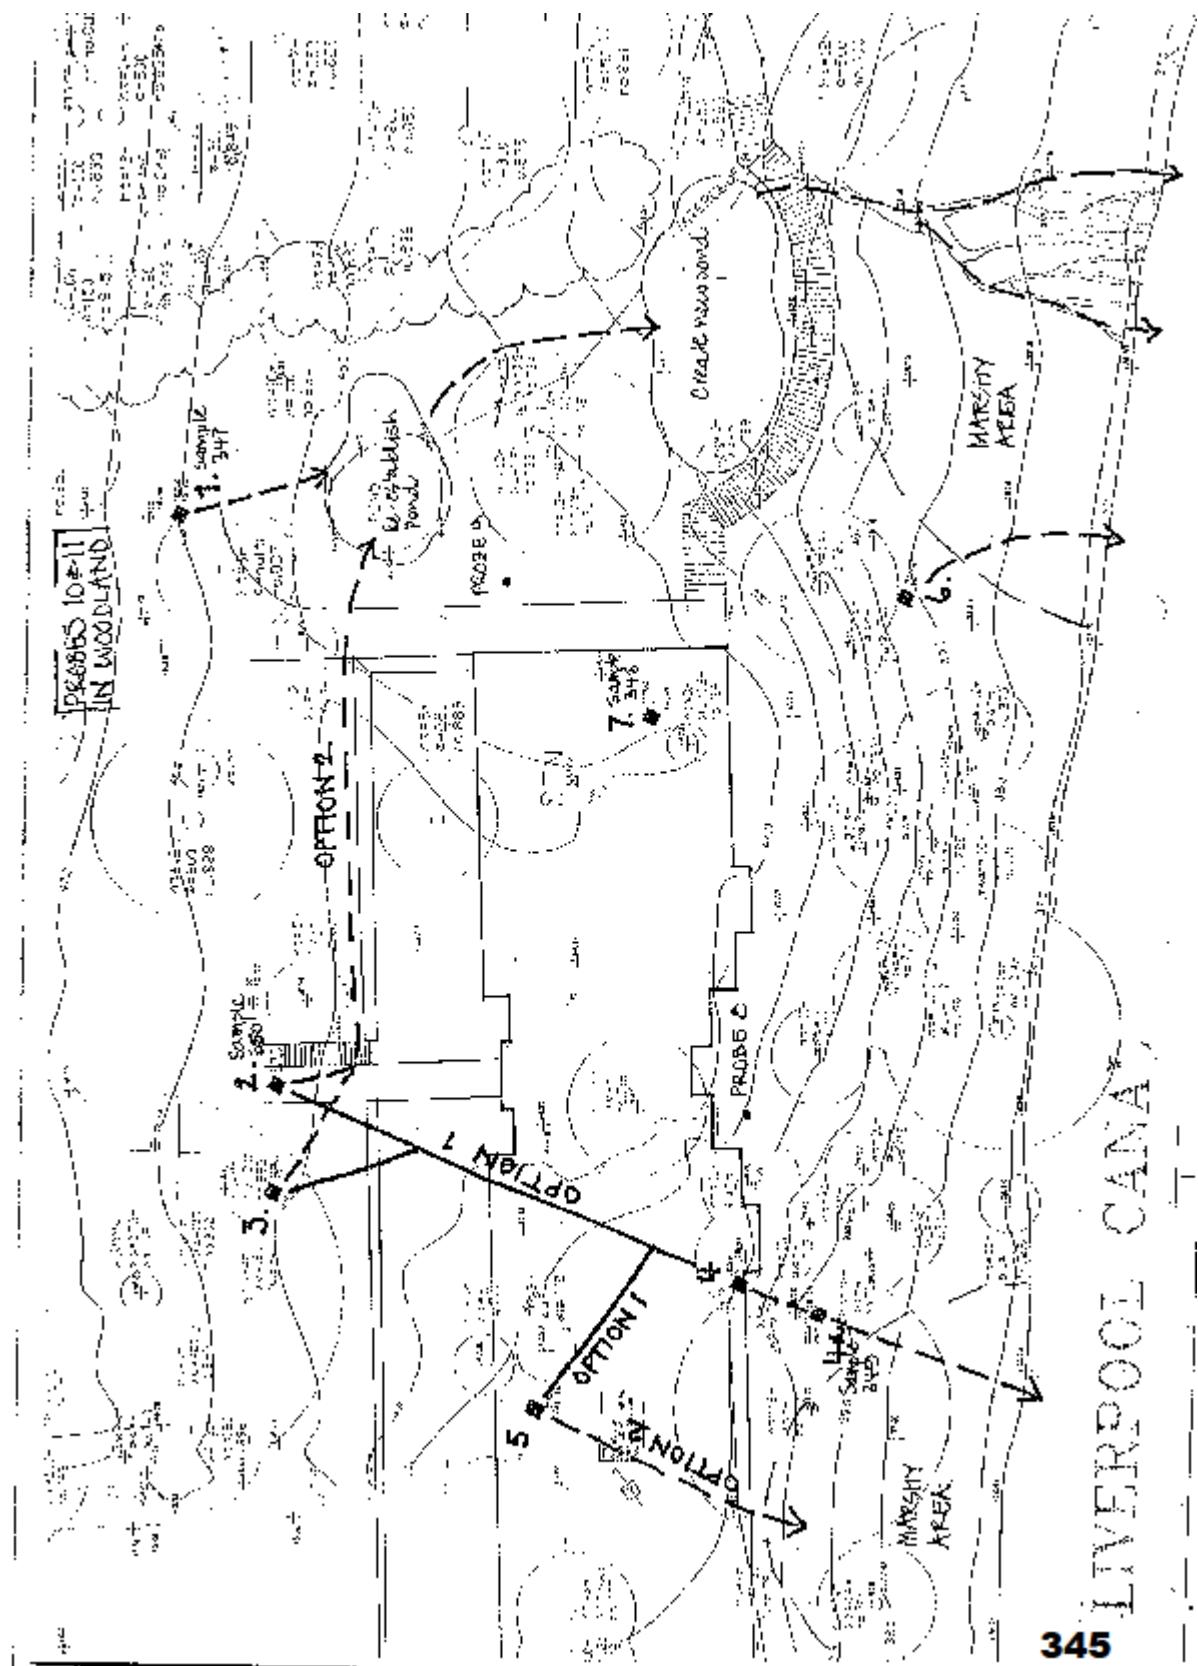
47. It will be seen from *Figure 3* that issues/springs 2 and 3 arise immediately to the west of the proposed F1/F2 Building, whilst issues/springs 4 and 5 arise underneath the footprint of the F1/F2 Building itself. Moreover, for issue/spring 5, both of the recommended options required culverting.
